# **Unique Support Surface Construction Materials Influence** Fluid Ingress, Longevity and Return on Investment

Neil Craney BSN, RN; Megan Hermann PT, DPT, CSPHA; Sarah Novotny PT, DPT, CWS, CLT-LANA, CFPS; Mikal Sanders PT, DPT; Stephanie Stoker BSN, RN; Kristen Thurman PT, MPT, CWS, CFPS

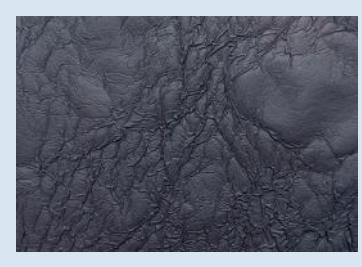
Standard Top Cover Fabric

Maior Acute Care Support Surface Manufacturers top cover immersed in bleach for 5 days resulting in full delamination

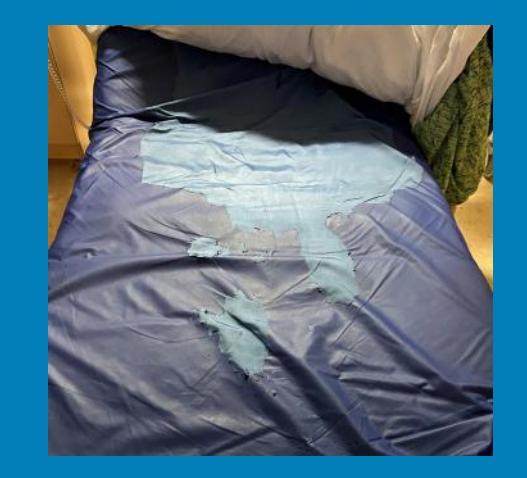
is eroded by harsh chemical **Result:** Degraded waterproofing material allows for fluid ingress

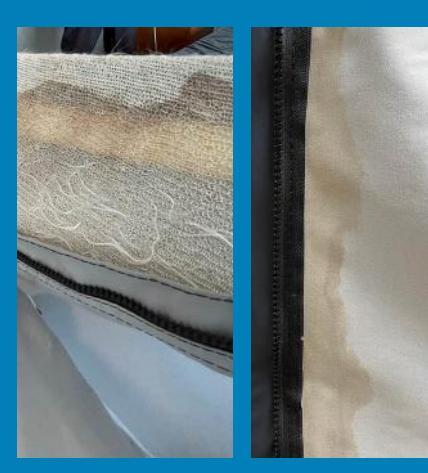
**Construction:** Sewn seams create permeate the interior components

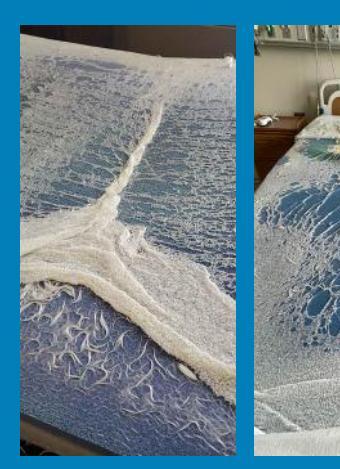
**Construction:** Fiberglass fire and is chemically treated. **Result:** No longer offers fire

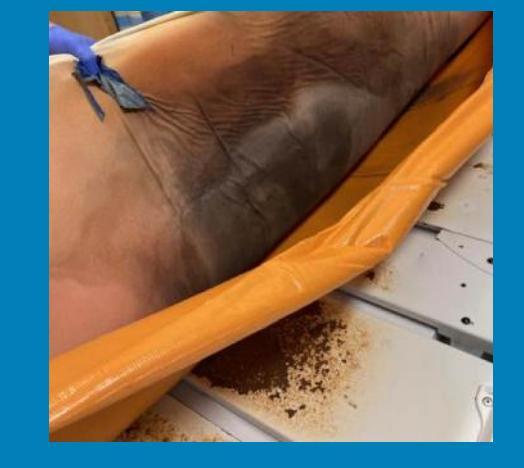
Construction: Unprotected interior components

Result: Fluid ingress and contamination of interior components, requires full replacement of the surface for patient safety.
