Support Surface Materials and Design Innovation: Preserving Integrity and Longevity in a Hospital Environment

Kristen Thurman, MPT, PT, CWS; Neil Craney, BSN, RN; Megan Hermann, DPT, PT, CSPHA

ABSTRACT

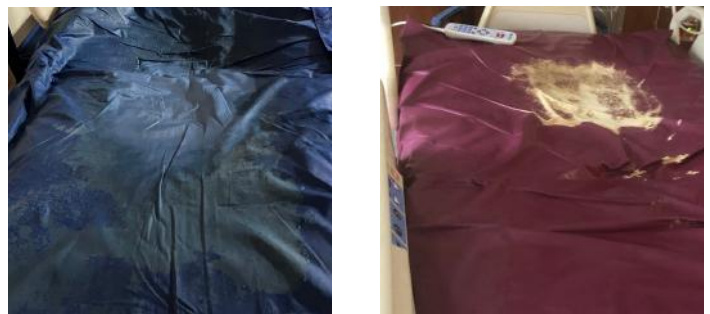
Figure 1: Top Cover Damage

Top cover damage due to chemical disinfectants and the utilization of top cover materials that cannot withstand the harsh hospital environment.

In addition to intensive patient use, support surface contamination is further exacerbated by top cover damage and/or breakdown due to the use of harsh chemical cleaning agents and improper cleaning and disinfecting procedures (*Figure 1*), which may allow for fluid ingress.¹ Hospital cleaning procedures require vigorous cleaning around mattress seams and soiled areas with harsh, unapproved chemicals for use on polyurethane coated material, leading to top cover breakdown and fluid permeability. Often these harsh disinfectants and cleansers are left on the top cover and not washed off once the indicated kill time was met. Leaving harsh chemicals on top cover fabrics breaks them down quickly, degrades their waterproofing, which then allows fluids to penetrate. The intact appearance of support surface top

covers can disguise contamination that can only be found through internal component inspection. This fluid ingress allows the internal components to harbor bacteria.¹⁸

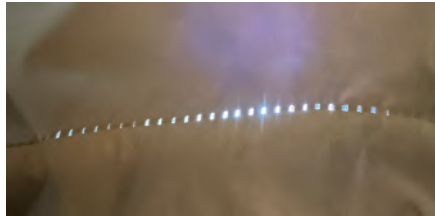
Sewn Seams

Traditional sewing methods punch thousands of holes into the fabric — creating openings for fluid ingress along every seam.

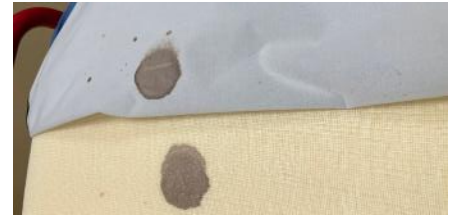
No CoreShield™

Typical design allows any fluid ingress to immediately damage internal components — likely requiring full asset replacement.

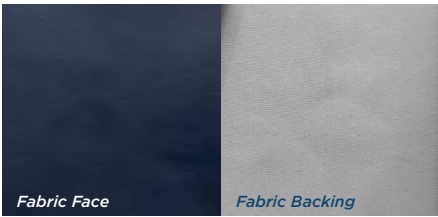
Specially Formulated Top Cover Fabric

(4-Way Stretch, Breathable, Waterproof)
Top cover immersed in bleach for ten days — resulting in no delamination.

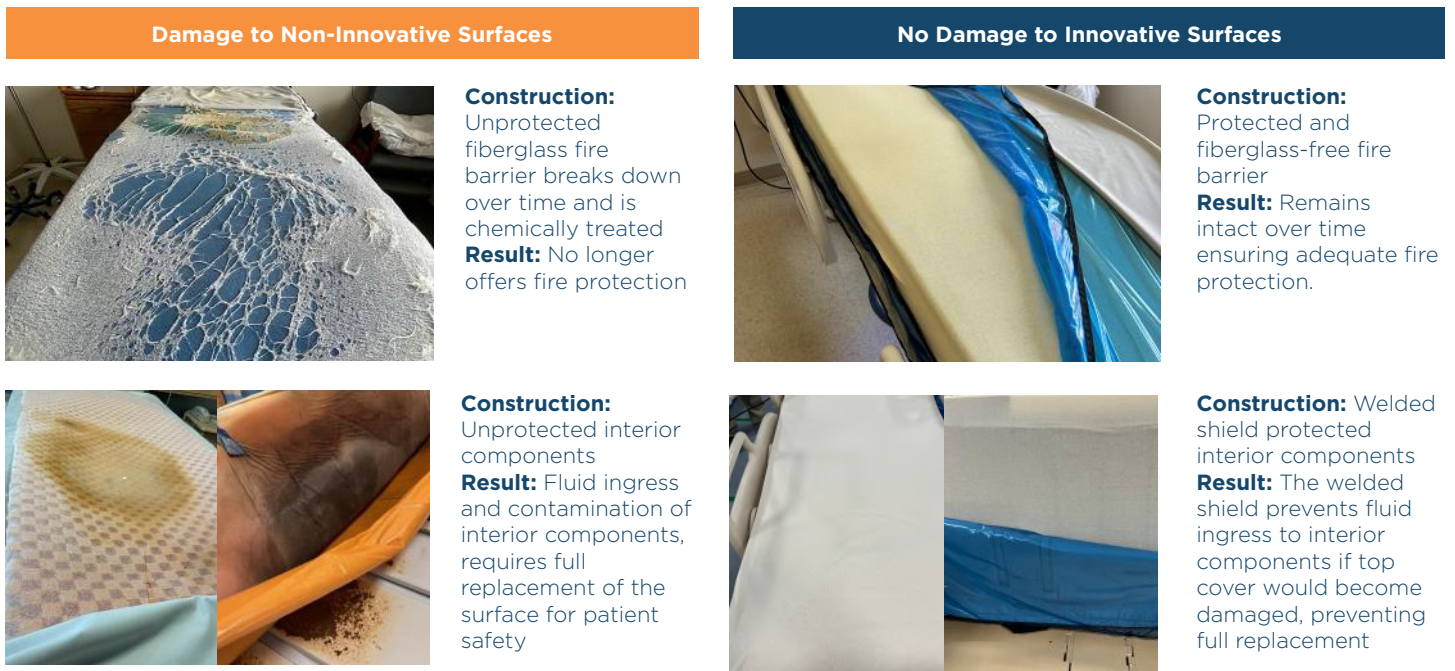
Figure 5: Internal Component Damage Without and With Innovative Materials and Construction

None (0%) of the Agiliti innovative surfaces had internal damage requiring full surface replacement, with only 21 surfaces (17%) requiring new top covers. In contrast, among the remaining 899 surfaces without innovative construction, 667 surfaces (74%) required full surface replacement due to top cover and internal damage and 741 surfaces (82%) had damaged top covers. Significantly fewer surfaces required replacements with the innovative materials and construction compared to the non-innovative surfaces ($p < 0.01$). (Table 1)

Top cover damage seen on non-innovative surfaces encompassed tears, micro-holes, damaged zippers and degradation of waterproofing from chemical cleansers. In contrast, the top cover of the Agiliti manufactured support surfaces showed no chemical degradation and intact waterproofing, while RF-welded seams prevented fluid ingress. Among damaged top covers, most non-innovative surfaces had significant staining from fluid ingress and compromised fire barriers. The Agiliti-manufactured surfaces showed no internal damage, as the CoreShield protected all internal components, when the top cover was compromised from physical damage.
