# Support Surface Materials and Design Innovation:

## Preventing Fluid Ingress and Maximizing Investment Returns for Hospitals

Neil Craney, BSN, RN; Megan Hermann, DPT, PT; Kristen Thurman, MPT, PT, CWS

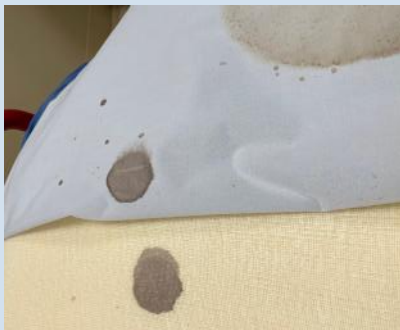
**Typical design allows any fluid ingress** to immediately damage internal components — likely requiring full asset replacement.

**Construction:** Unprotected interior components

**Result:** Fluid ingress and contamination of interior components, requires full replacement of the surface for patient safety

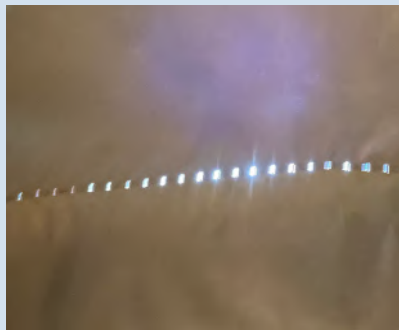
**Traditional sewing methods** punch thousands of holes into the fabric, creating openings for fluid ingress along every seam.

**Construction:** Sewn seams create thousands of holes in cover

**Result:** Holes allow fluid to permeate the interior components

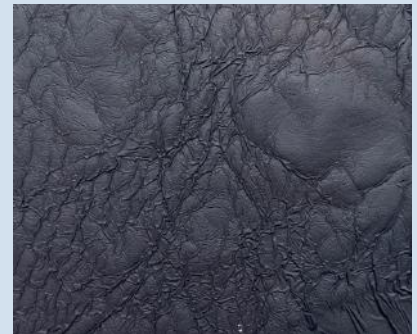
**Most top cover fabrics** lose their waterproofing when exposed to disinfecting chemicals — allowing for fluid ingress (*photos: 5 days in bleach*).

**Construction:** Top cover material is eroded by harsh chemical cleansers

**Result:** Degraded waterproofing material allows for fluid ingress

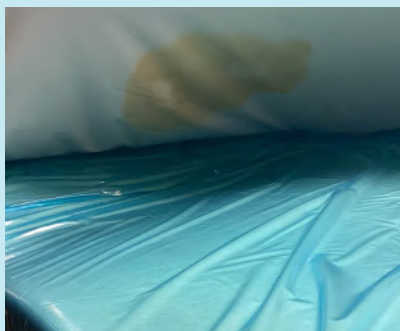
**CoreShield™ liner protects** the internal components from potential fluid ingress and damage — likely requiring only top cover replacement.

**Construction:** Welded shield protected interior components

**Result:** The welded shield prevents fluid ingress to interior components if top cover would get damaged, further preventing full replacement

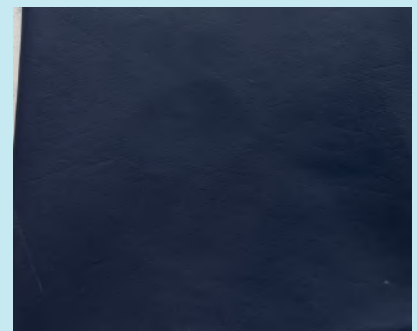
**Highly chemically resistant fabrics** withstand harsh cleaning protocols and help maintain a waterproof covering (*photos: 10 days in bleach*).

**Construction:** Specially formulated top cover fabric

**Result:** No delamination of waterproofing, maintains integrity, and no fluid ingress
