# **Unique Support Surface Construction Materials Influence** Fluid Ingress, Longevity and Return on Investment

Neil Craney BSN, RN; Megan Hermann PT, DPT, CSPHA; Sarah Novotny PT, DPT, CWS, CLT-LANA, CFPS; Mikal Sanders PT, DPT; Stephanie Stoker BSN, RN; Kristen Thurman PT, MPT, CWS, CFPS

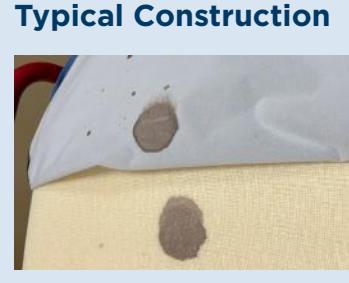
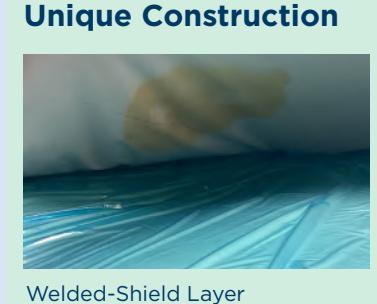
No Welded-Shield Layer

Sewn seams

Standard Top Cover Fabric

Maior Acute Care Support Surface Manufacturers top cover immersed in bleach for 5 days resulting in full delamination

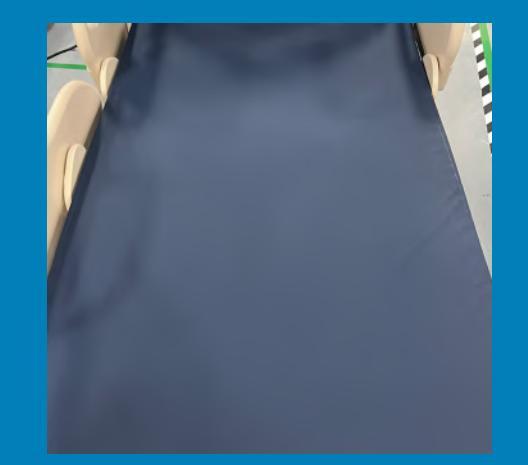
**Construction:** Specially waterproofing, maintains integrity, and no fluid ingress

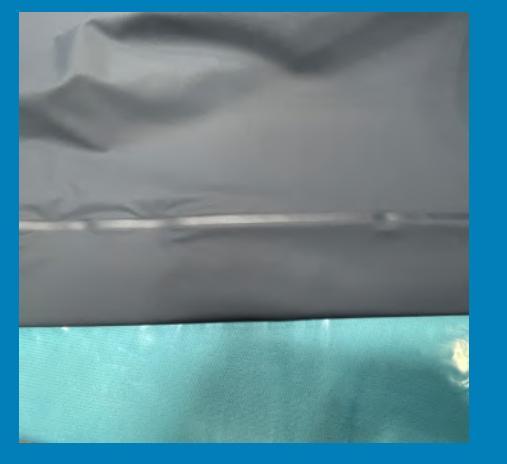
**Construction:** RF-welded seams permanently bond the material on **Result:** Avoiding holes to join fabric prevents fluid intrusion

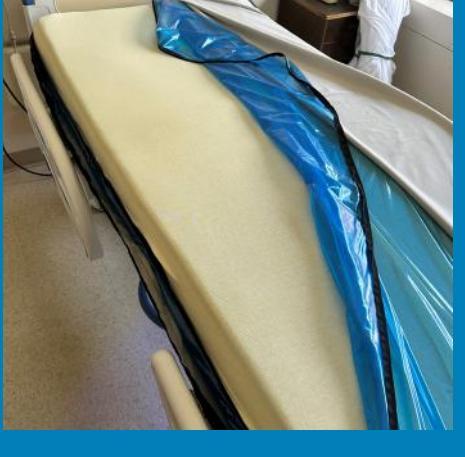
**Construction:** Fiberglass-free fire **Result:** Remains intact over time ensuring adequate fire protection.

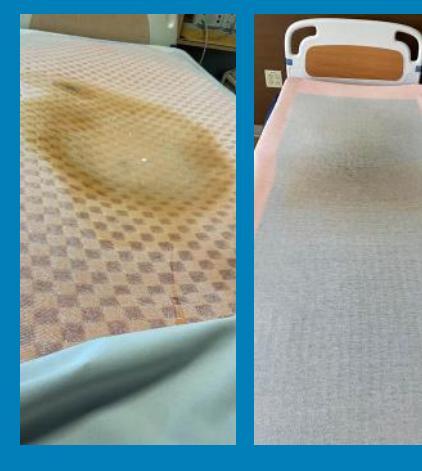
Construction: Unprotected interior components

Result: Fluid ingress and contamination of interior components, requires full replacement of the surface for patient safety.

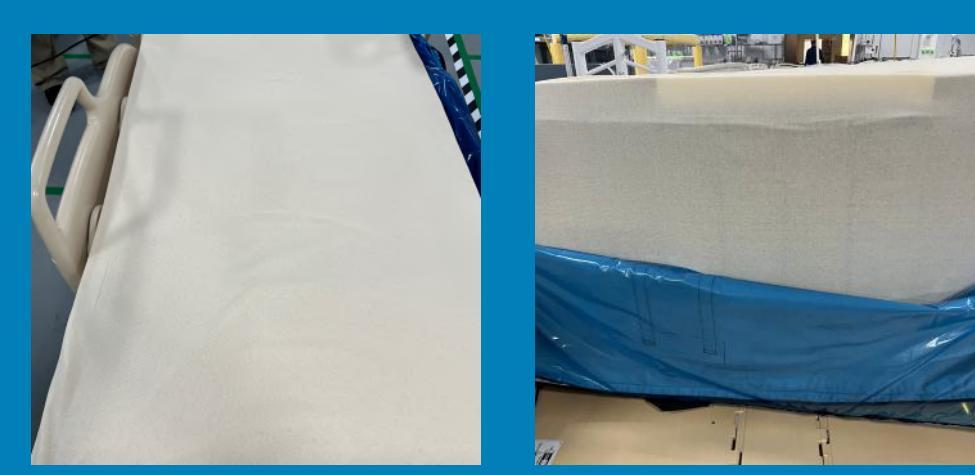
**Construction:** Welded shield protected interior components

**Result:** The welded shield prevents fluid ingress to interior components if top cover would get damaged, further preventing full replacement
